Manhole Inspection Summary

Manhole # S21E__057MH

Location Address: **128 MOUNT ST**

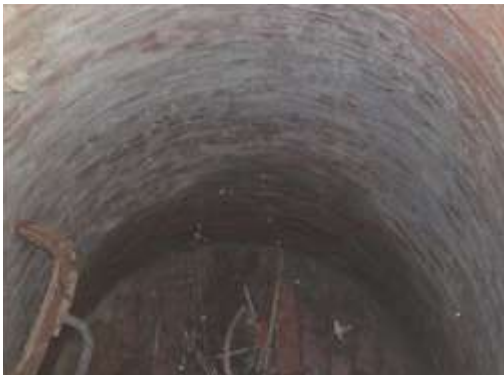
Defect 2

Infiltration: ☐ None ☐ Joint ☐ Cracks ☐ Mortar ☐ Roots ☒ **Wall**

BARREL INFILTRATION

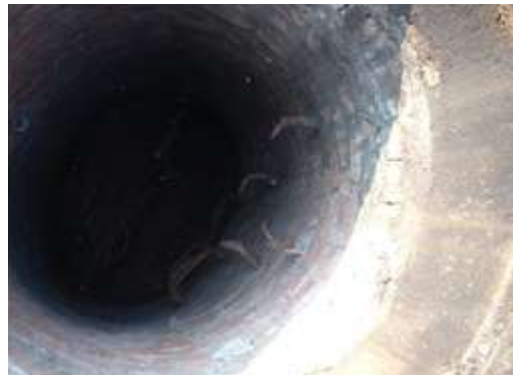
Defect 1

Count: **2** Missing: **4** ☒ **Corroded**

CORRODED AND MISSING STEPS

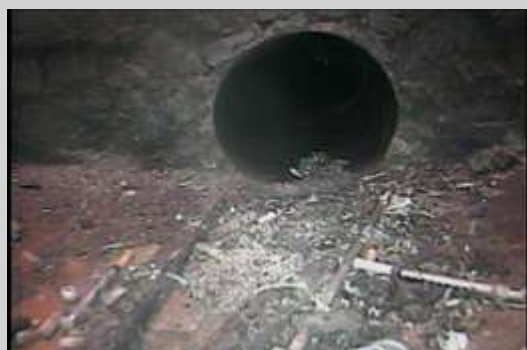
12 O'Clock Outflow

DEBRIS IN CHANNEL

Deposits: ☐ None ☐ Mud ☐ Sludge ☒ **Debris** ☐ Grease

Silt Depth: **1** (in.) Deposits Extent: **Light**
